May 1985

# Broadkill River Flood Plain Management Study

## Sussex County, Delaware

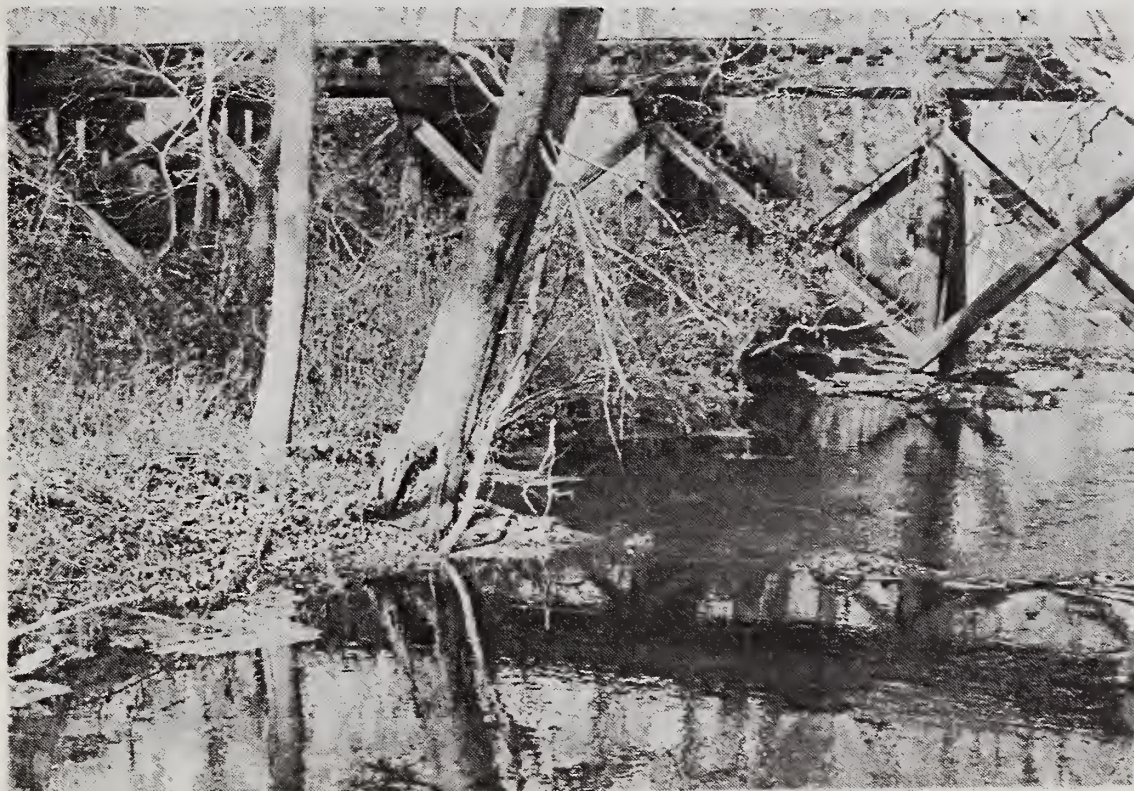
The railroad crossing in this area, however, could create an unstable debris dam against the trestle in the event of failure of Diamond Pond dam, compounding downstream flooding problems.

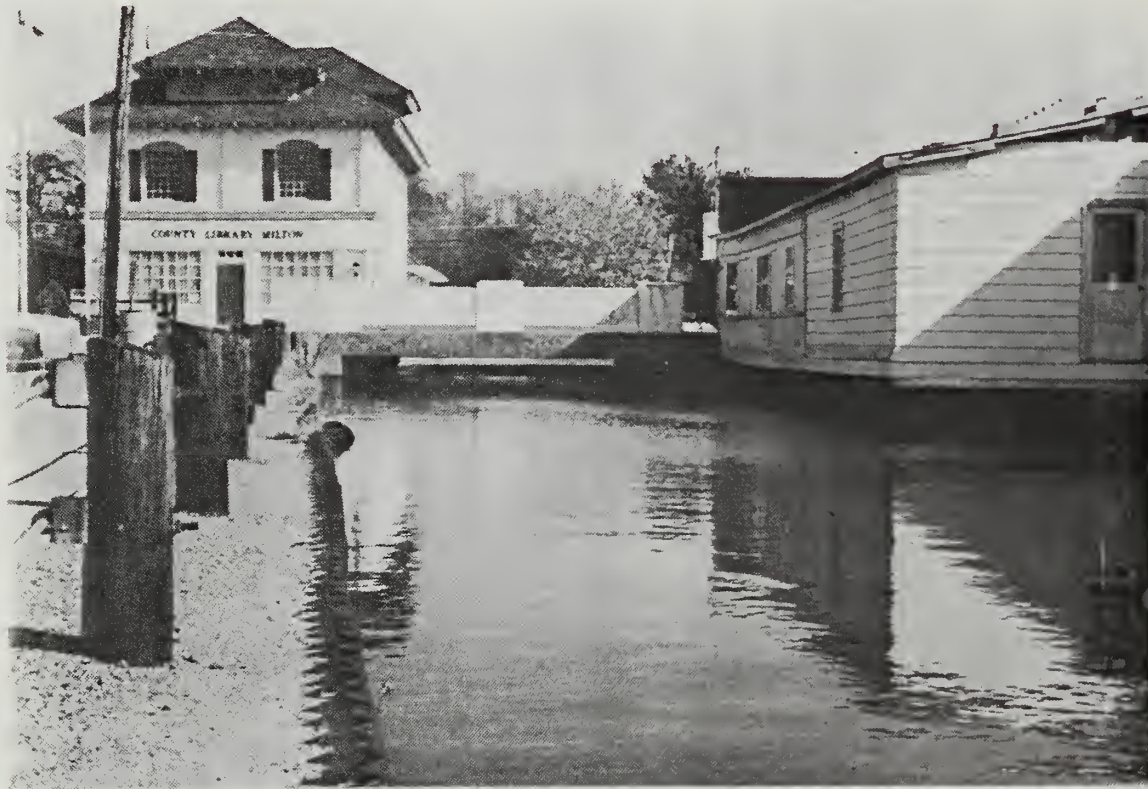
Previous development on the flood plain restricts flood flows. The Milton business district including Union, Magnolia, and Front Streets encroach on the flood plain. The Union Street crossing is especially restrictive forcing flood flows to spread through the community.

The current sewage treatment plant expansion may contribute a slight negative effect to flood plain values, due to encroachment.

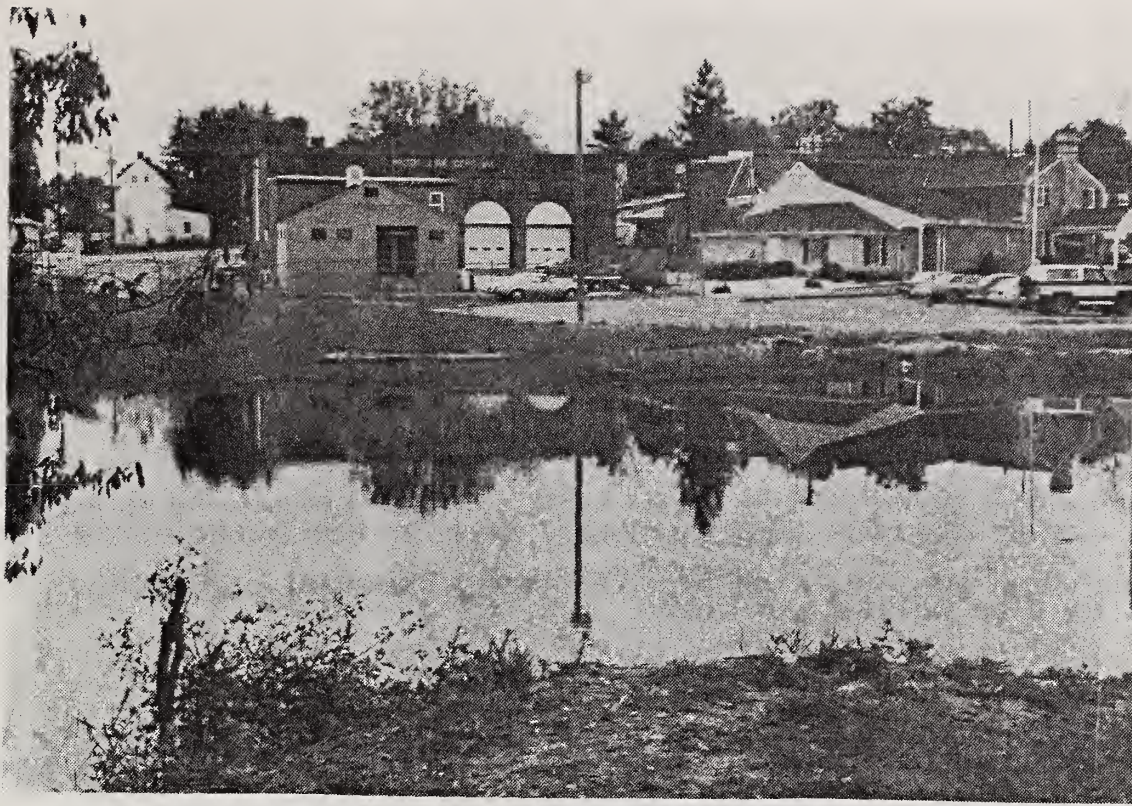
Positive impacts of the town of Milton on the flood plain include the establishment of auto parking areas off Magnolia and Front Streets and development of a community park off Chandler Street.

Floodwaters can spread in these areas and cause little damage.
